**Subject: Revised Final Phase II Environmental Site Assessment Report  
Tennessee Wheel and Rubber TBA Site  
Nashville, Davidson County, Tennessee  
EPA Contract No. EP-W-05-054 (START III Region 4)  
Technical Direction Document No. TTEMI-05-003-0052**

**REVISED FINAL  
PHASE II ENVIRONMENTAL SITE ASSESSMENT REPORT**

**TENNESSEE WHEEL AND RUBBER TBA SITE  
NASHVILLE, DAVIDSON COUNTY, TENNESSEE**

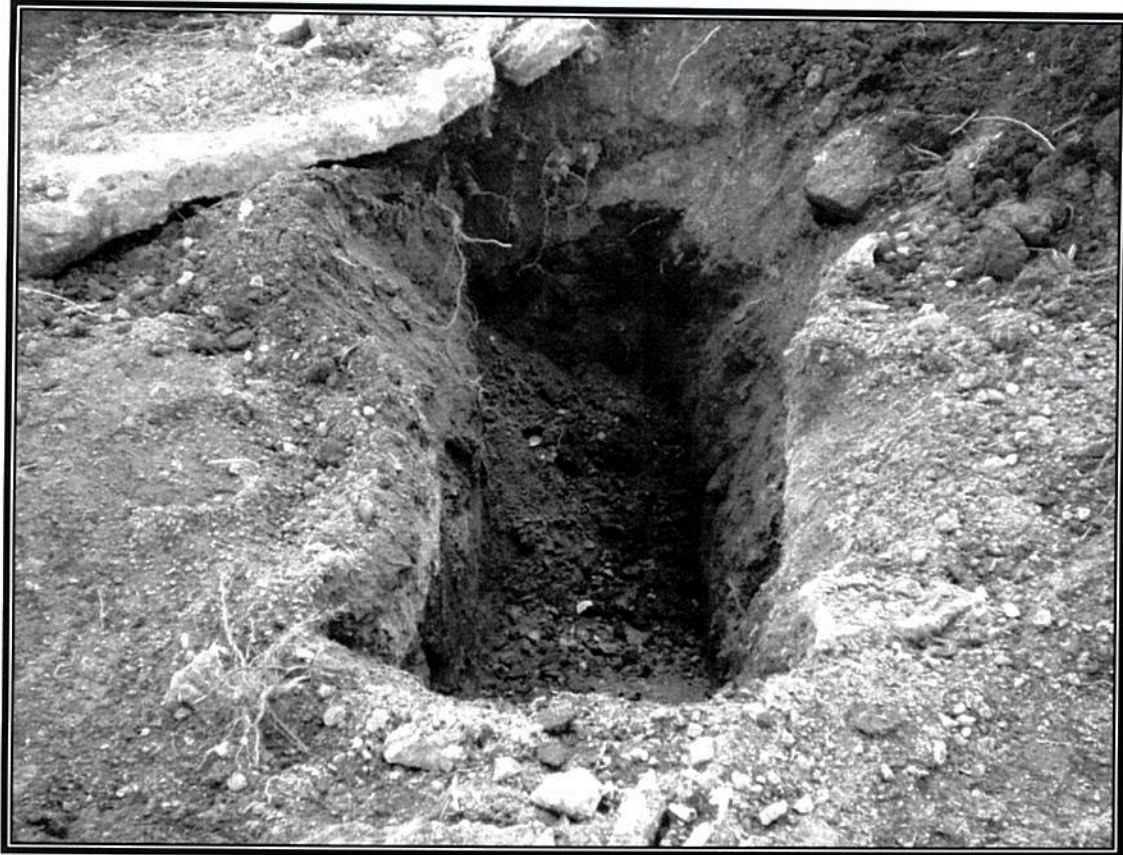
**OFFICIAL PHOTOGRAPH NO. 1**  
**U.S. ENVIRONMENTAL PROTECTION AGENCY**

<b>TDD Number:</b>	TTEMI-05-003-0052	<b>Location:</b>	Tennessee Wheel and Rubber TBA
<b>Orientation:</b>	West	<b>Date:</b>	February 25, 2009
<b>Photographer:</b>	Tim Ward, Tetra Tech	<b>Witness:</b>	John Galler, Tetra Tech
<b>Subject:</b>	An excavated location in the area of the suspected underground storage tank (UST) located on the northern portion of the property.

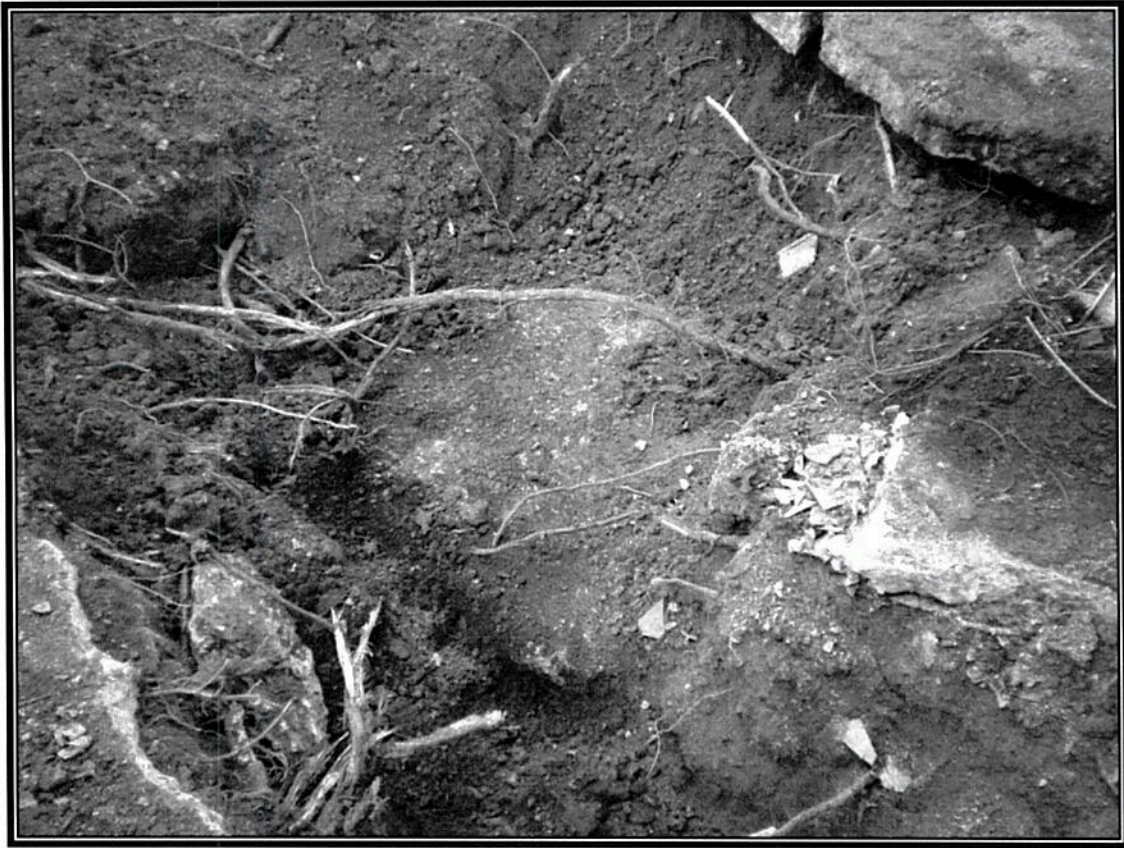
**OFFICIAL PHOTOGRAPH NO. 2**  
**U.S. ENVIRONMENTAL PROTECTION AGENCY**

**Subject:** A partially buried concrete slab at the northern suspected UST location. This slab is believed to be covering the top of a UST. The slab was uncovered approximately 2-3 feet below ground surface.

Tetra Tech utilized an excavation subcontractor to excavate around the areas of the fill ports in an effort to visually inspect the tanks. At both locations, a rough-formed concrete pad was discovered approximately 2 to 3 feet bgs and non-native sand was observed immediately beneath the concrete pad where the sides of the pad were excavated. A protective, painted steel barrier around each fill port appeared to be attached to the concrete pad. At the south UST area, a steel line routed towards the southern building was discovered beneath the concrete pad.

Based on previous experience, Tetra Tech has found that a concrete pad is typically placed over an UST to prevent the tank from rising to the surface during periods of heavy rain and/or vadose zone shift. In addition, the subsurface concrete pad may have interfered with the electromagnetic survey conducted on February 5, 2009. Finally, fine-grain sand is typically associated with UST installation in general.

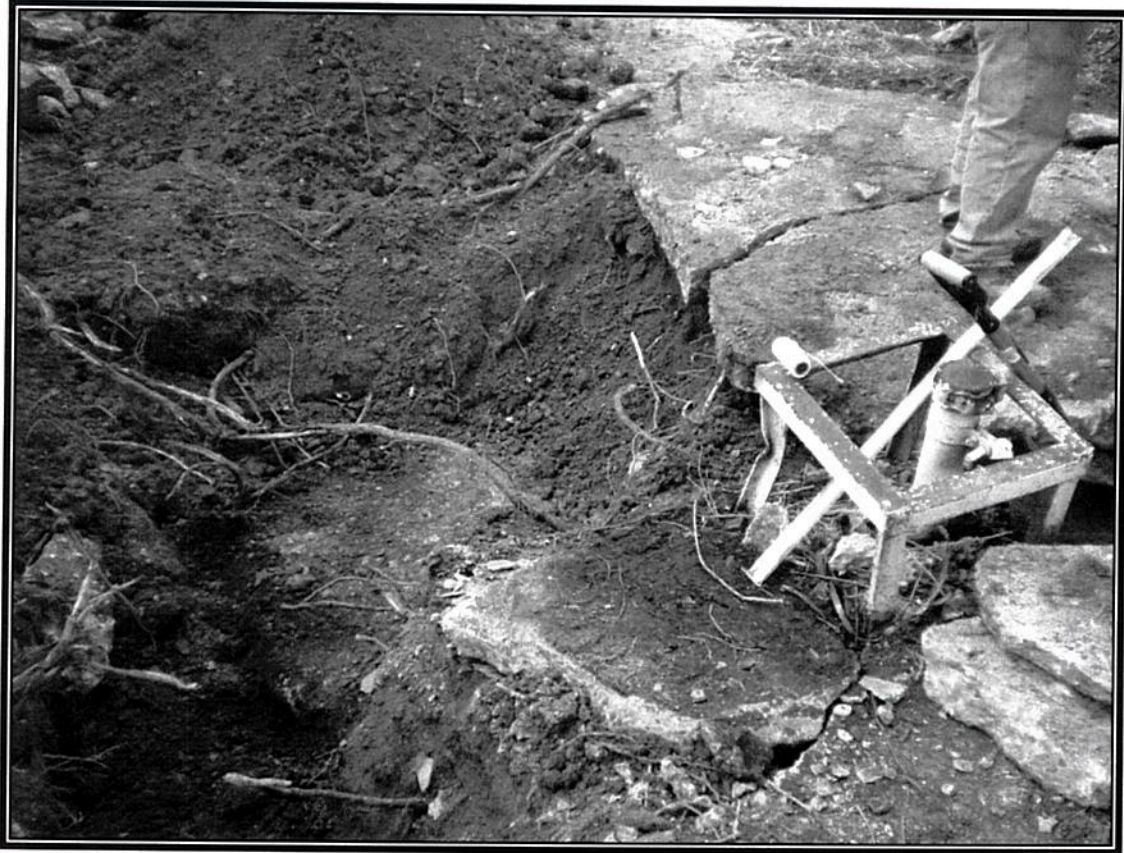
**OFFICIAL PHOTOGRAPH NO. 3  
U.S. ENVIRONMENTAL PROTECTION AGENCY**

<b>TDD Number:</b>	TTEMI-05-003-0052	<b>Location:</b>	Tennessee Wheel and Rubber TBA
<b>Orientation:</b>	West	<b>Date:</b>	February 25, 2009
<b>Photographer:</b>	Tim Ward, Tetra Tech	<b>Witness:</b>	John Galler, Tetra Tech
<b>Subject:</b>	The UST fill pipe in relation to the buried concrete slab at the northern suspected UST location.

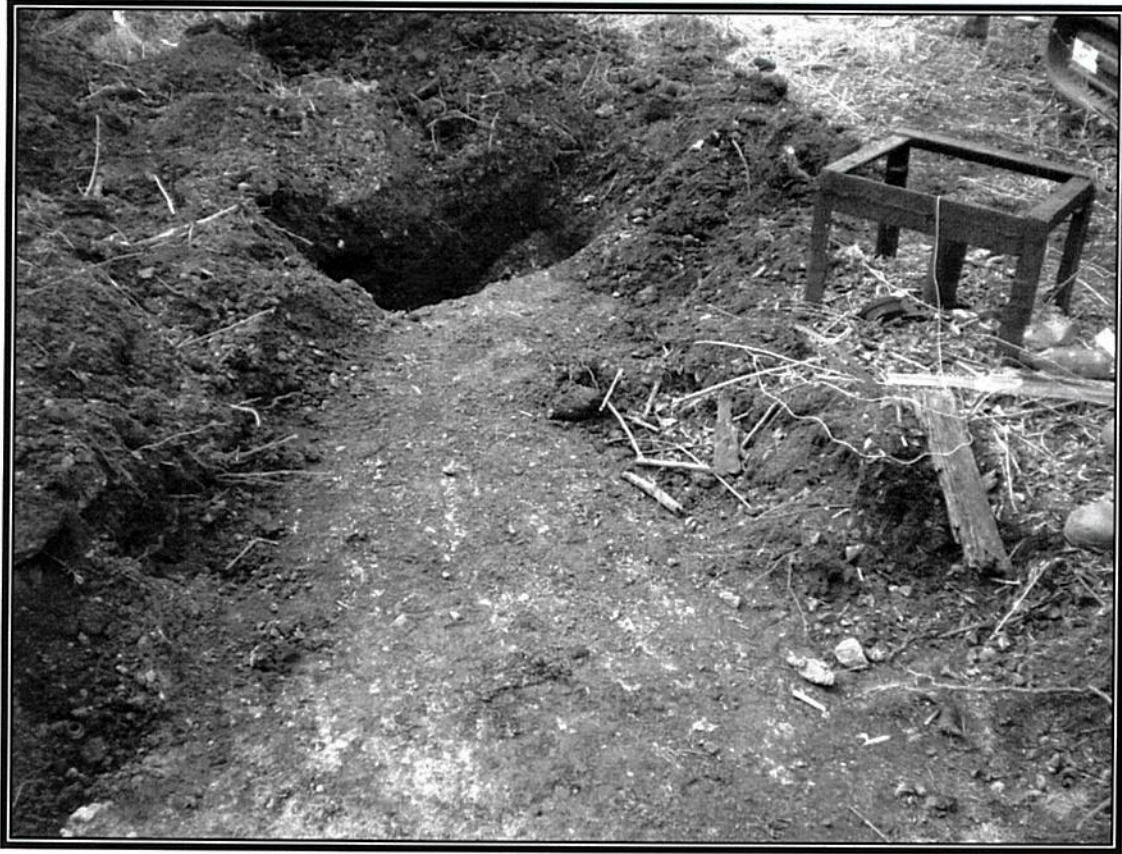
**OFFICIAL PHOTOGRAPH NO. 5  
U.S. ENVIRONMENTAL PROTECTION AGENCY**

<b>TDD Number:</b>	TTEMI-05-003-0052	<b>Location:</b>	Tennessee Wheel and Rubber TBA
<b>Orientation:</b>	Northwest	<b>Date:</b>	February 25, 2009
<b>Photographer:</b>	Tim Ward, Tetra Tech	<b>Witness:</b>	John Galler, Tetra Tech
<b>Subject:</b>	The UST fill pipe in relation to the buried concrete slab at the southern suspected UST location.

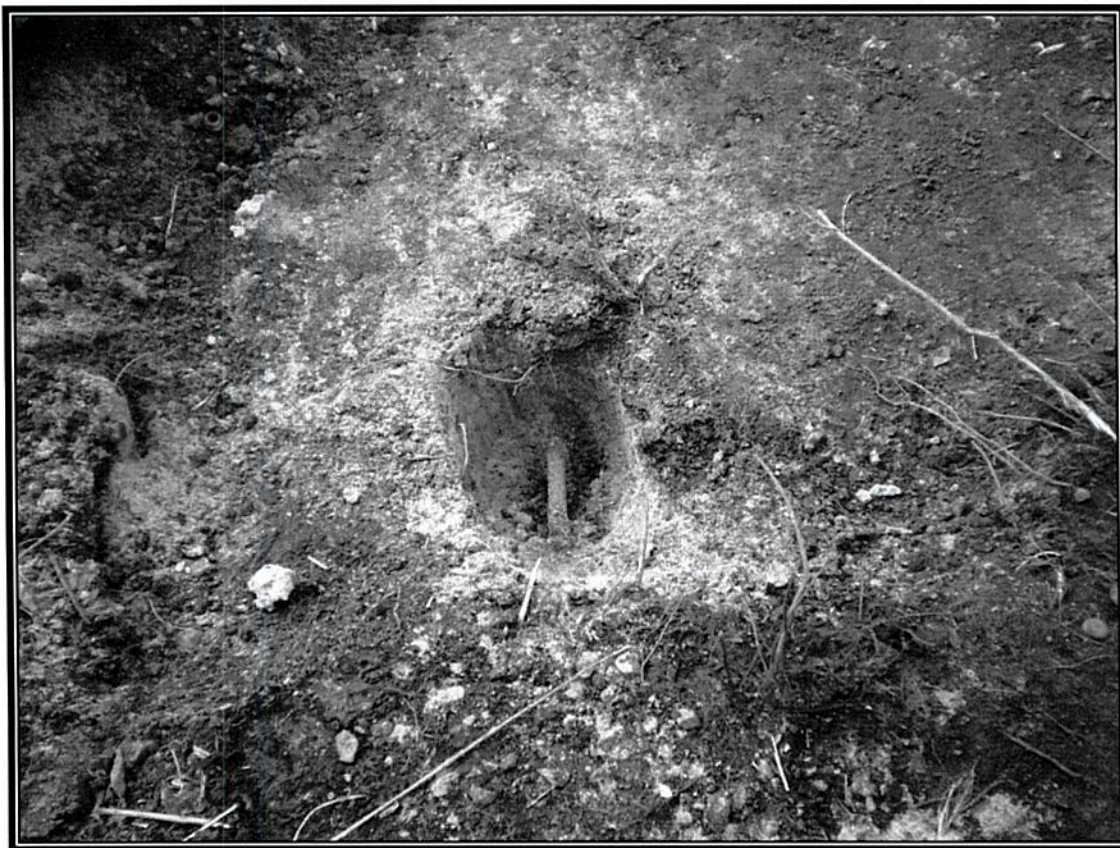
**OFFICIAL PHOTOGRAPH NO. 6**  
**U.S. ENVIRONMENTAL PROTECTION AGENCY**

**Subject:** A suspected product transport line or vent pipeline at the southern suspected UST location. This feature was uncovered and appears to be routed beneath the slab mentioned previously.

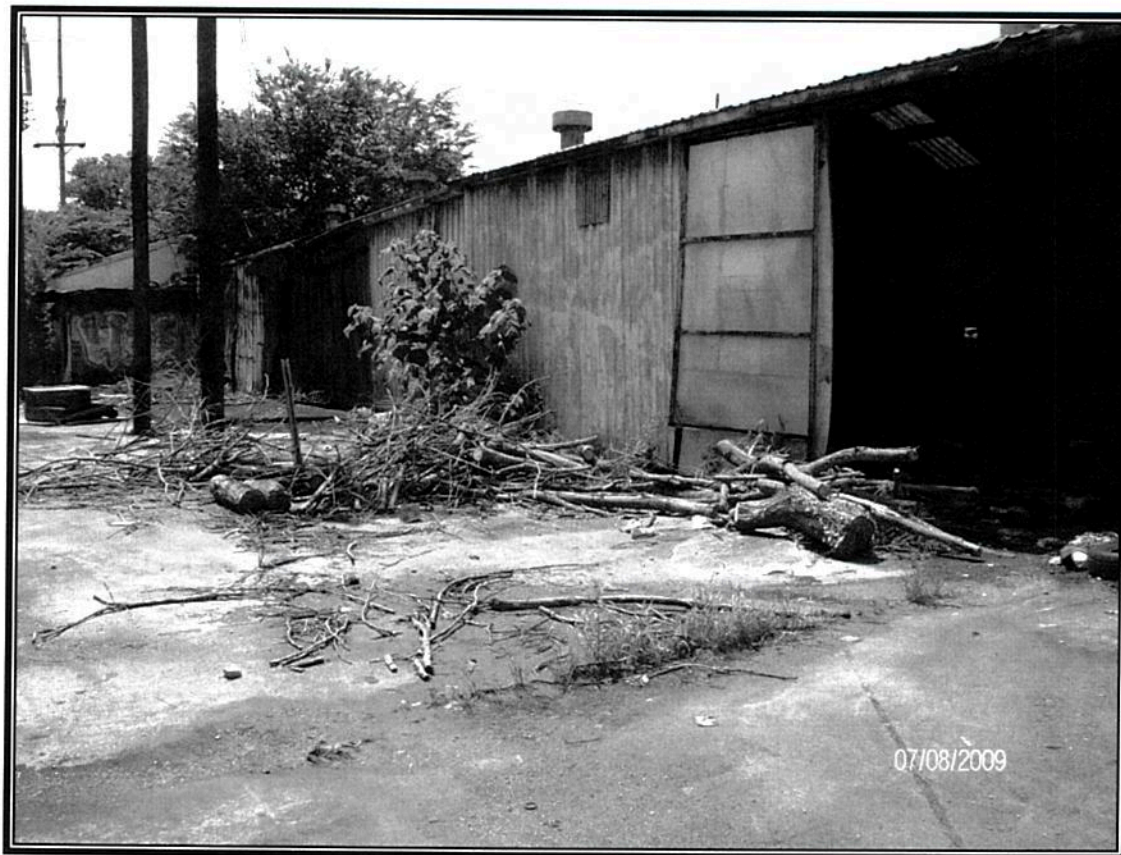
**OFFICIAL PHOTOGRAPH NO. 7**  
**U.S. ENVIRONMENTAL PROTECTION AGENCY**

<b>TDD Number:</b>	TTEMI-05-003-0052	<b>Location:</b>	Tennessee Wheel and Rubber TBA
<b>Orientation:</b>	West	<b>Date:</b>	July 8, 2009
<b>Photographer:</b>	James Caruthers, Tetra Tech	<b>Witness:</b>	Tim Ward, Tetra Tech
<b>Subject:</b>	Illegal dumping on site hindering access to drilling locations

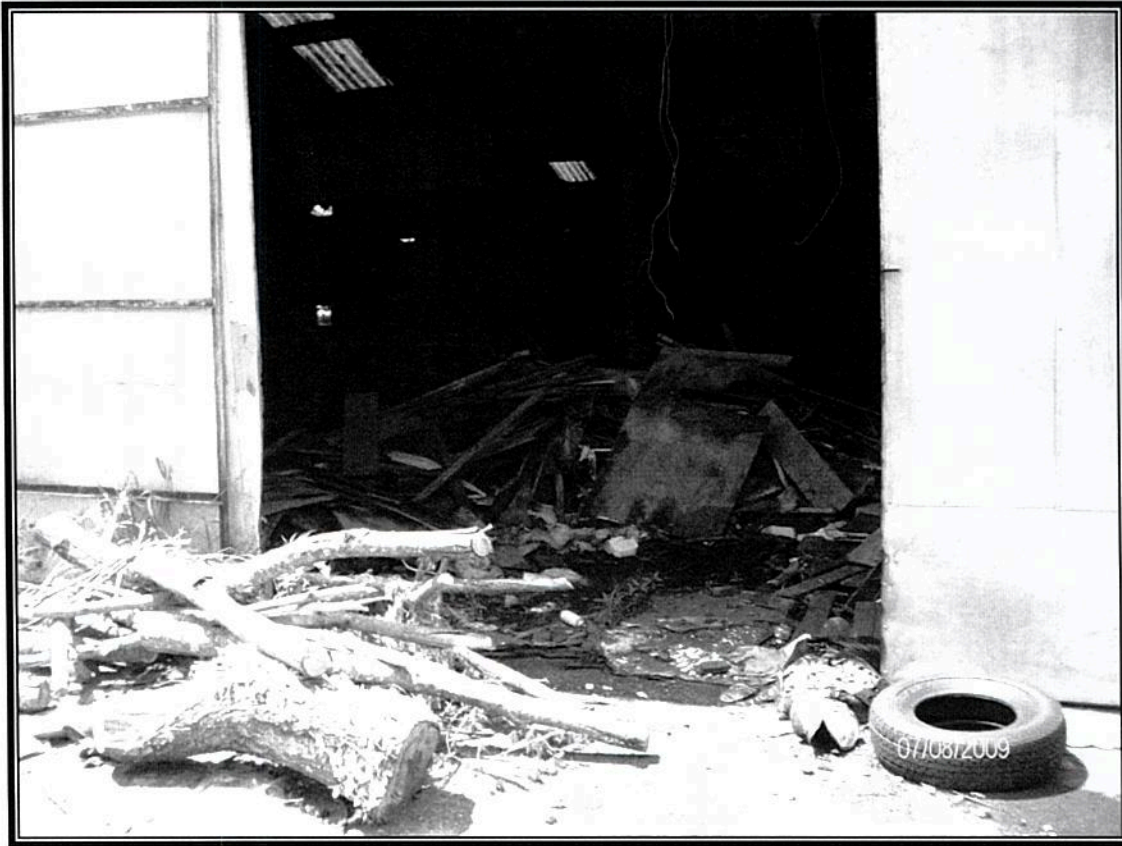
**OFFICIAL PHOTOGRAPH NO. 8**  
**U.S. ENVIRONMENTAL PROTECTION AGENCY**

<b>TDD Number:</b>	TTEMI-05-003-0052	<b>Location:</b>	Tennessee Wheel and Rubber TBA
<b>Orientation:</b>	Northwest	<b>Date:</b>	July 8, 2009
<b>Photographer:</b>	James Caruthers, Tetra Tech	<b>Witness:</b>	Tim Ward, Tetra Tech
<b>Subject:</b>	Illegal dumping on site hindering access to drilling locations. Debris in doorway

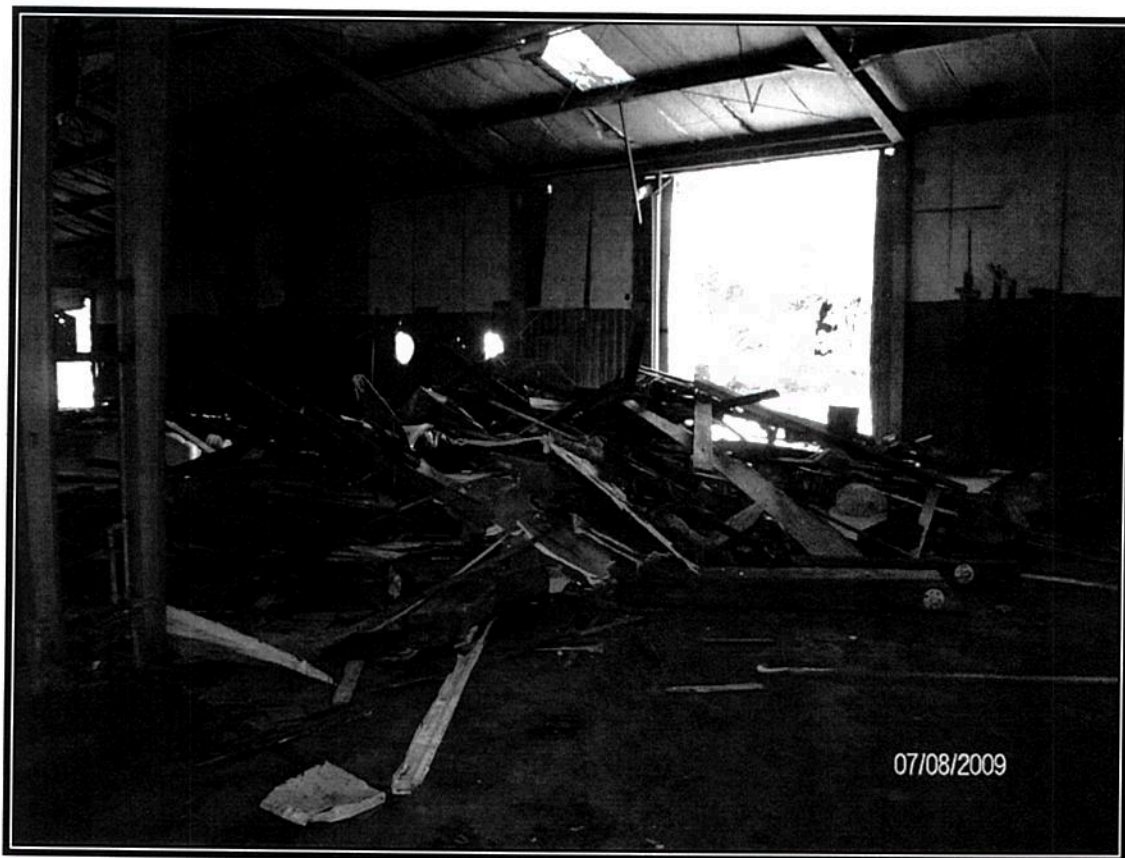
**OFFICIAL PHOTOGRAPH NO. 9**  
**U.S. ENVIRONMENTAL PROTECTION AGENCY**

**TDD Number:** TTEMI-05-003-0052      **Location:** Tennessee Wheel and Rubber TBA  
**Orientation:** East      **Date:** July 8, 2009  
**Photographer:** James Caruthers, Tetra Tech      **Witness:** Tim Ward, Tetra Tech  
**Subject:** Illegal dumping on site hindering access to drilling locations. Debris in doorway

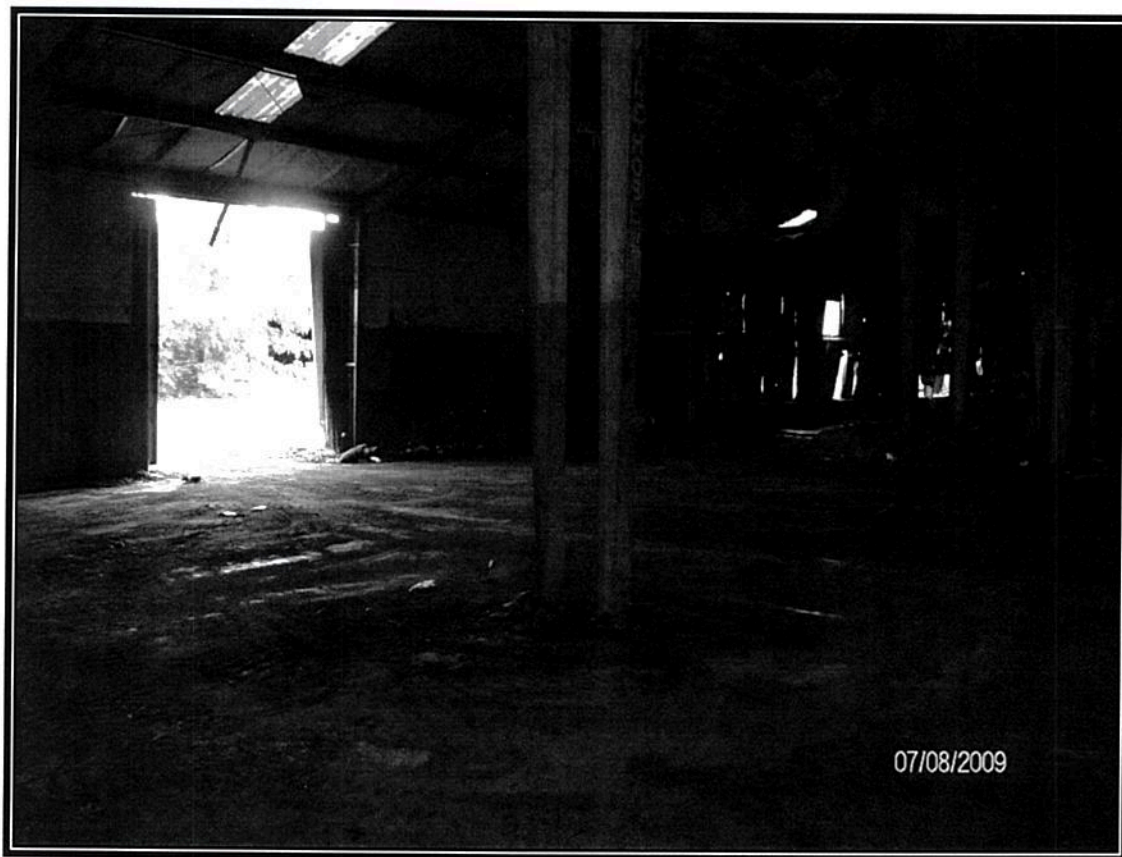
**OFFICIAL PHOTOGRAPH NO. 10**  
**U.S. ENVIRONMENTAL PROTECTION AGENCY**

**Subject:** Clearing and stock piling debris

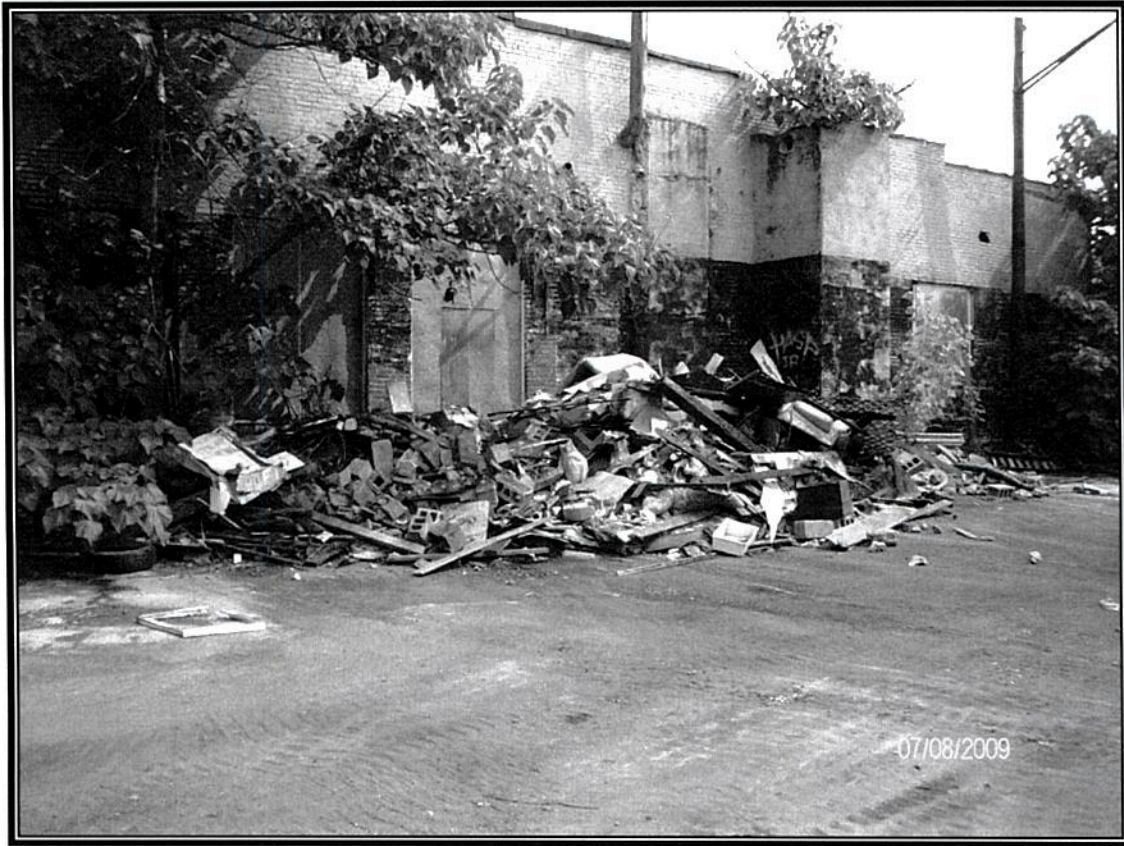
**OFFICIAL PHOTOGRAPH NO. 13**  
**U.S. ENVIRONMENTAL PROTECTION AGENCY**

**TDD Number:** TTEMI-05-003-0052      **Location:** Tennessee Wheel and Rubber TBA  
**Orientation:** Southwest      **Date:** July 8, 2009  
**Photographer:** James Caruthers, Tetra Tech      **Witness:** Tim Ward, Tetra Tech  
**Subject:** Area after debris clean up with debris pile to the left

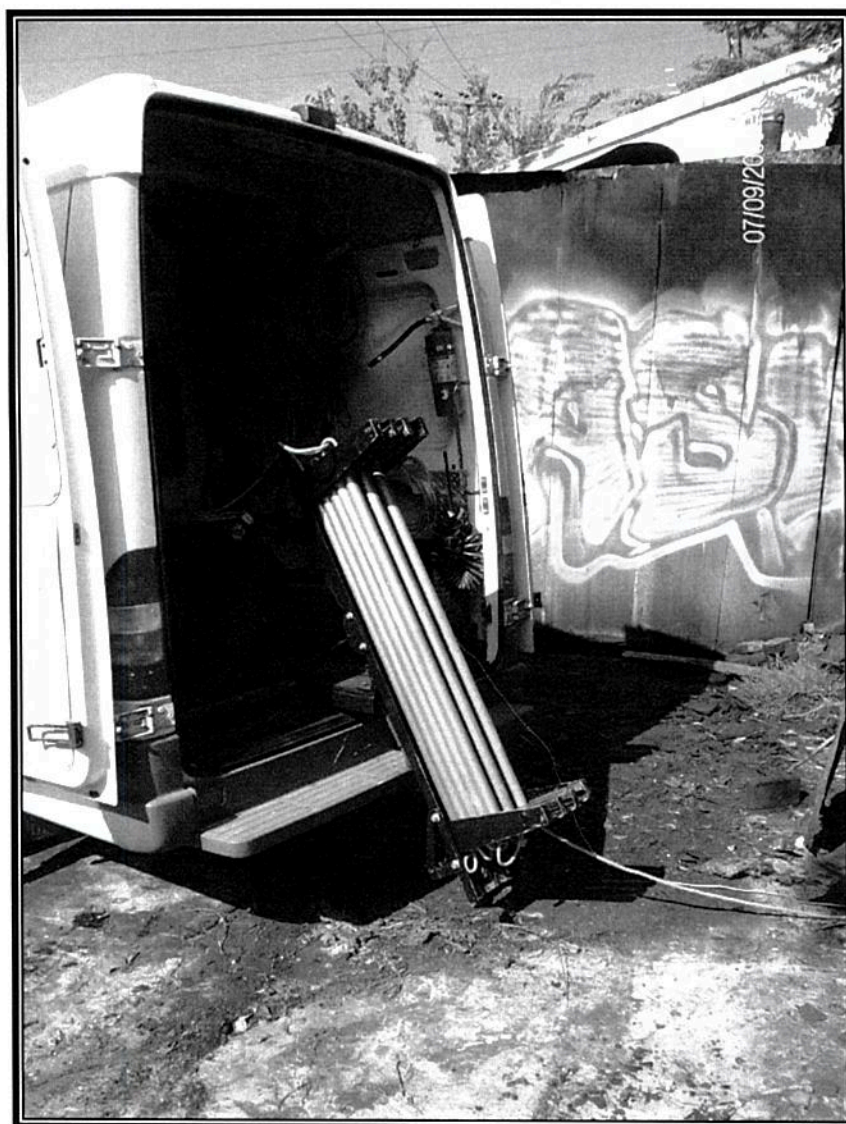
**OFFICIAL PHOTOGRAPH NO. 16**  
**U.S. ENVIRONMENTAL PROTECTION AGENCY**

**Subject:** MIP van and drill rods

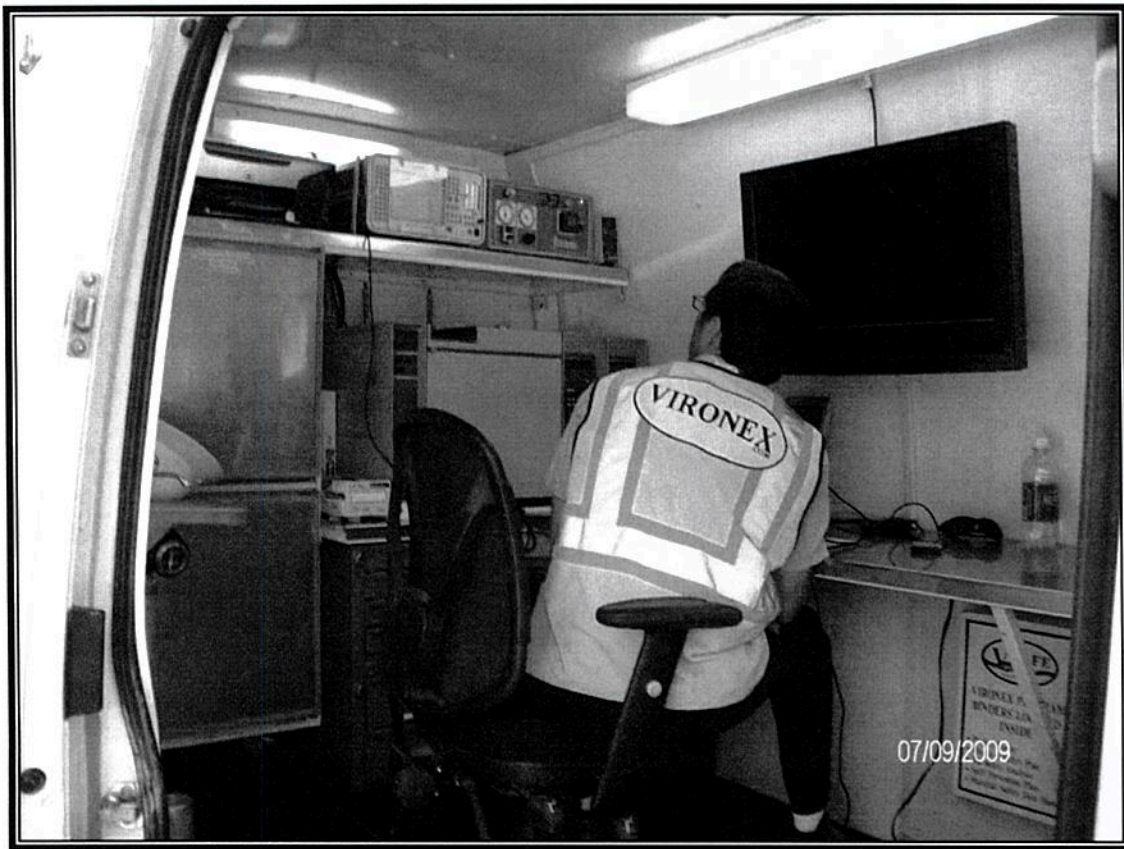
**OFFICIAL PHOTOGRAPH NO. 18**  
**U.S. ENVIRONMENTAL PROTECTION AGENCY**

**TDD Number:** TTEMI-05-003-0052      **Location:** Tennessee Wheel and Rubber TBA  
**Orientation:** East      **Date:** July 9, 2009  
**Photographer:** James Caruthers, Tetra Tech      **Witness:** Chuck Terry, Vironex  
**Subject:** Chuck Terry of Vironex inside MIP van with data recording equipment

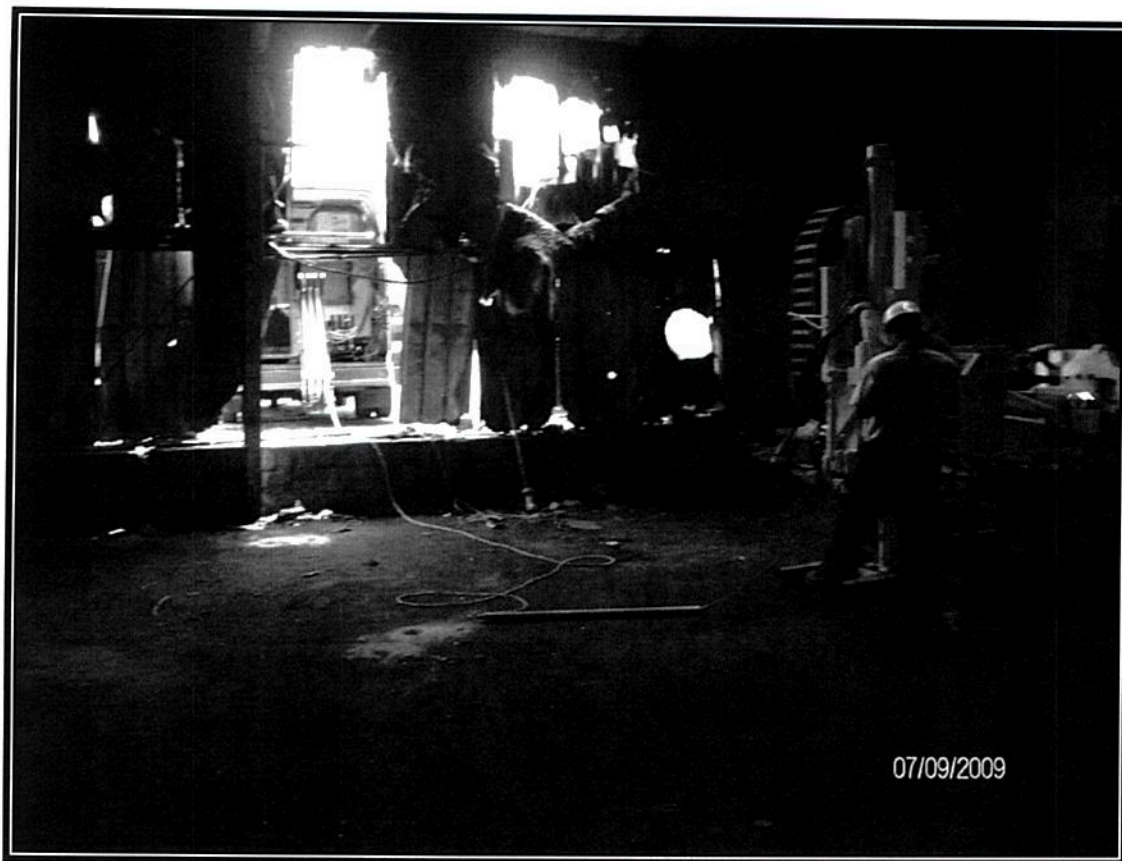
**OFFICIAL PHOTOGRAPH NO. 19**  
**U.S. ENVIRONMENTAL PROTECTION AGENCY**

<b>TDD Number:</b>	TTEMI-05-003-0052	<b>Location:</b>	Tennessee Wheel and Rubber TBA
<b>Orientation:</b>	South	<b>Date:</b>	July 9, 2009
<b>Photographer:</b>	James Caruthers, Tetra Tech	<b>Witness:</b>	Chuck Terry, Vironex
<b>Subject:</b>	MIP rig and van on boring MIP-5

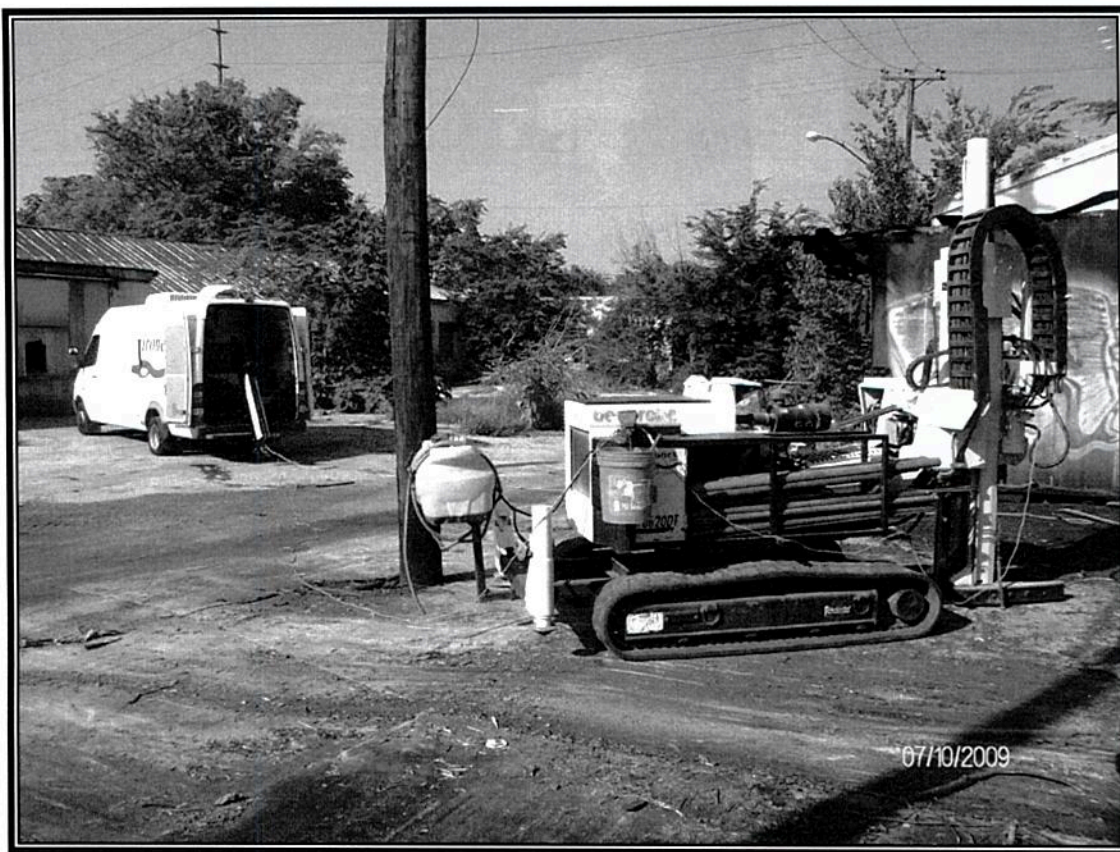
**OFFICIAL PHOTOGRAPH NO. 20**  
**U.S. ENVIRONMENTAL PROTECTION AGENCY**

**Subject:** MIP rig and van on boring MIP-12

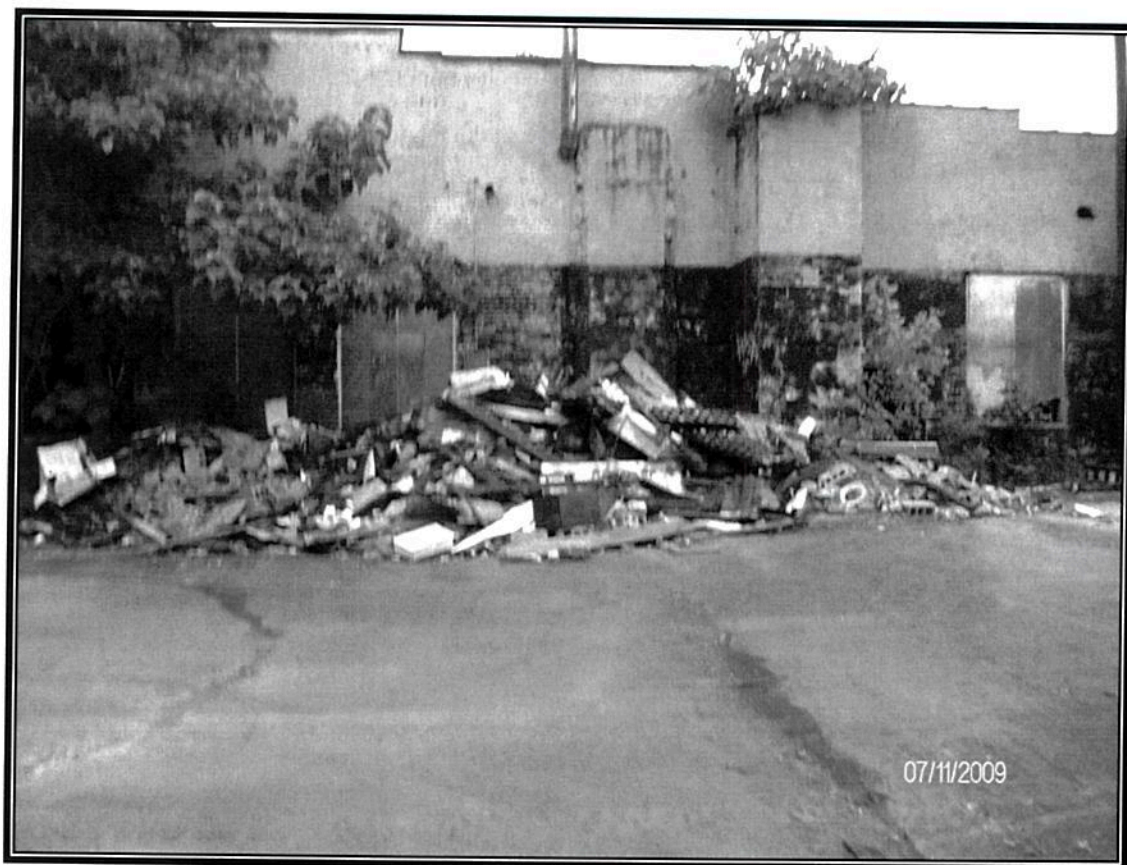
**OFFICIAL PHOTOGRAPH NO. 24**  
**U.S. ENVIRONMENTAL PROTECTION AGENCY**

<b>TDD Number:</b>	TTEMI-05-003-0052	<b>Location:</b>	Tennessee Wheel and Rubber TBA
<b>Orientation:</b>	Southwest	<b>Date:</b>	July 11, 2009
<b>Photographer:</b>	James Caruthers, Tetra Tech	<b>Witness:</b>	Cory Gamwell, Vironex
<b>Subject:</b>	Site as left after MIP investigation

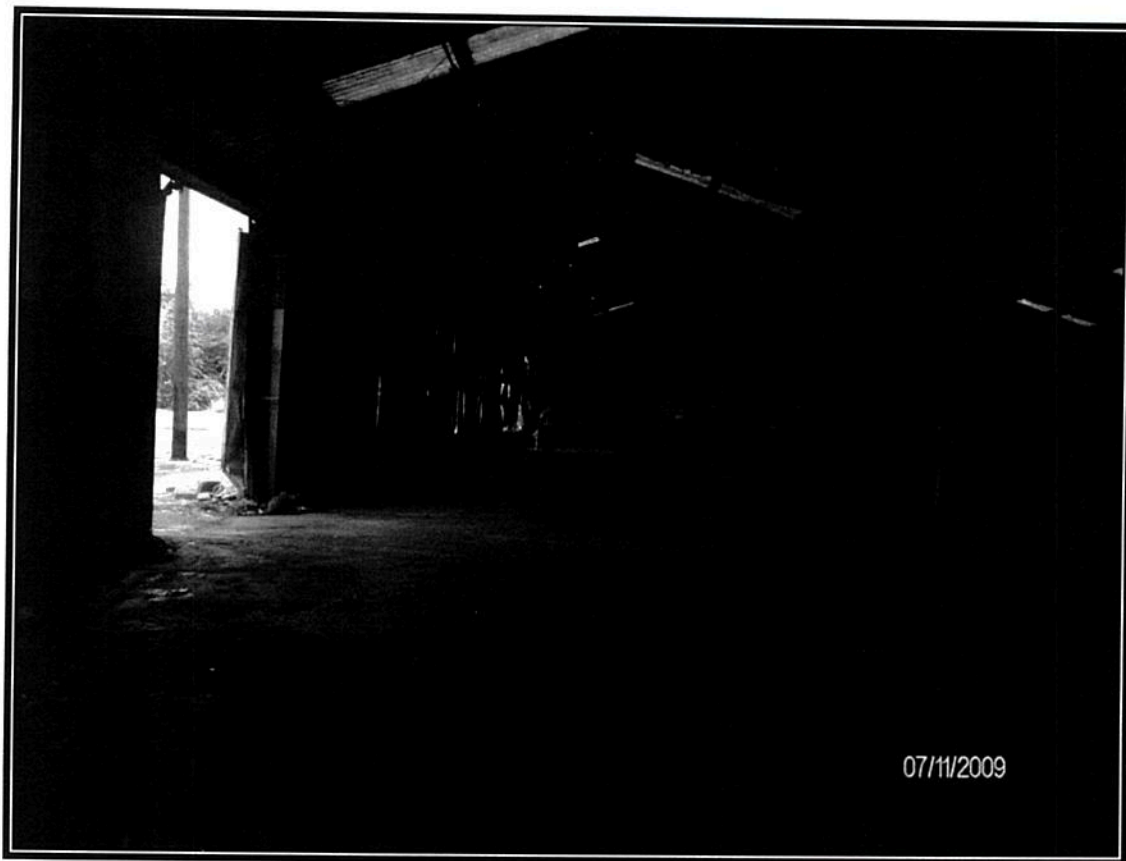
**OFFICIAL PHOTOGRAPH NO. 26**  
**U.S. ENVIRONMENTAL PROTECTION AGENCY**

<b>TDD Number:</b>	TTEMI-05-003-0052	<b>Location:</b>	Tennessee Wheel and Rubber TBA
<b>Orientation:</b>	North	<b>Date:</b>	July 11, 2009
<b>Photographer:</b>	James Caruthers, Tetra Tech	<b>Witness:</b>	Cory Gamwell, Vironex
<b>Subject:</b>	Site as left after MIP investigation
